CVSID LAKE SEQUOYAH DAM ENGINEERING EVALUATION & CONCEPTUAL DESIGN

Public Meeting - November 17, 2025

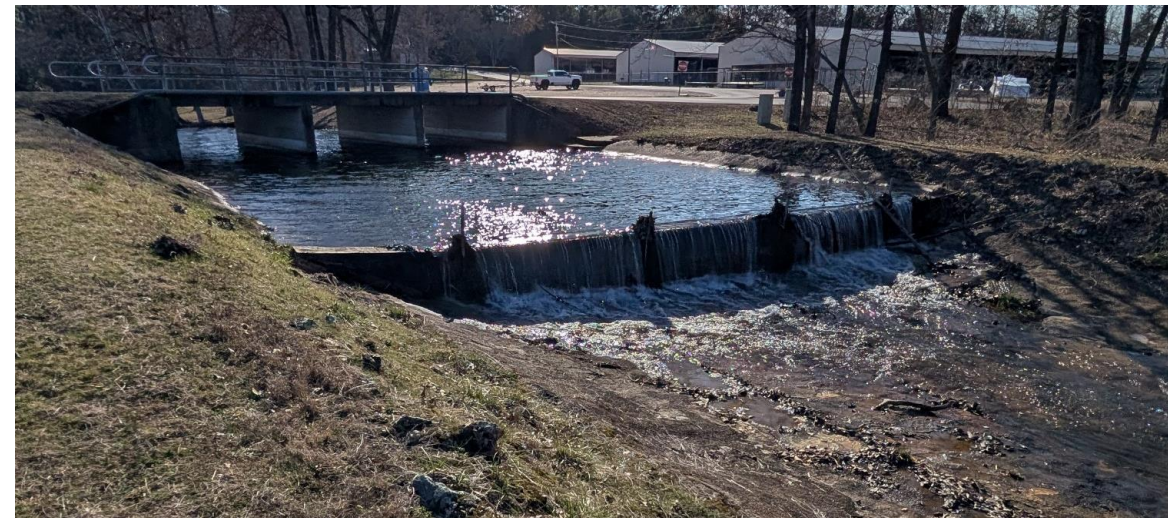
EXISTING DAM SECTION

Existing downstream slope $\pm 2:1$ (H:V)

Normal Pool 478.36 – Set by wooden weir

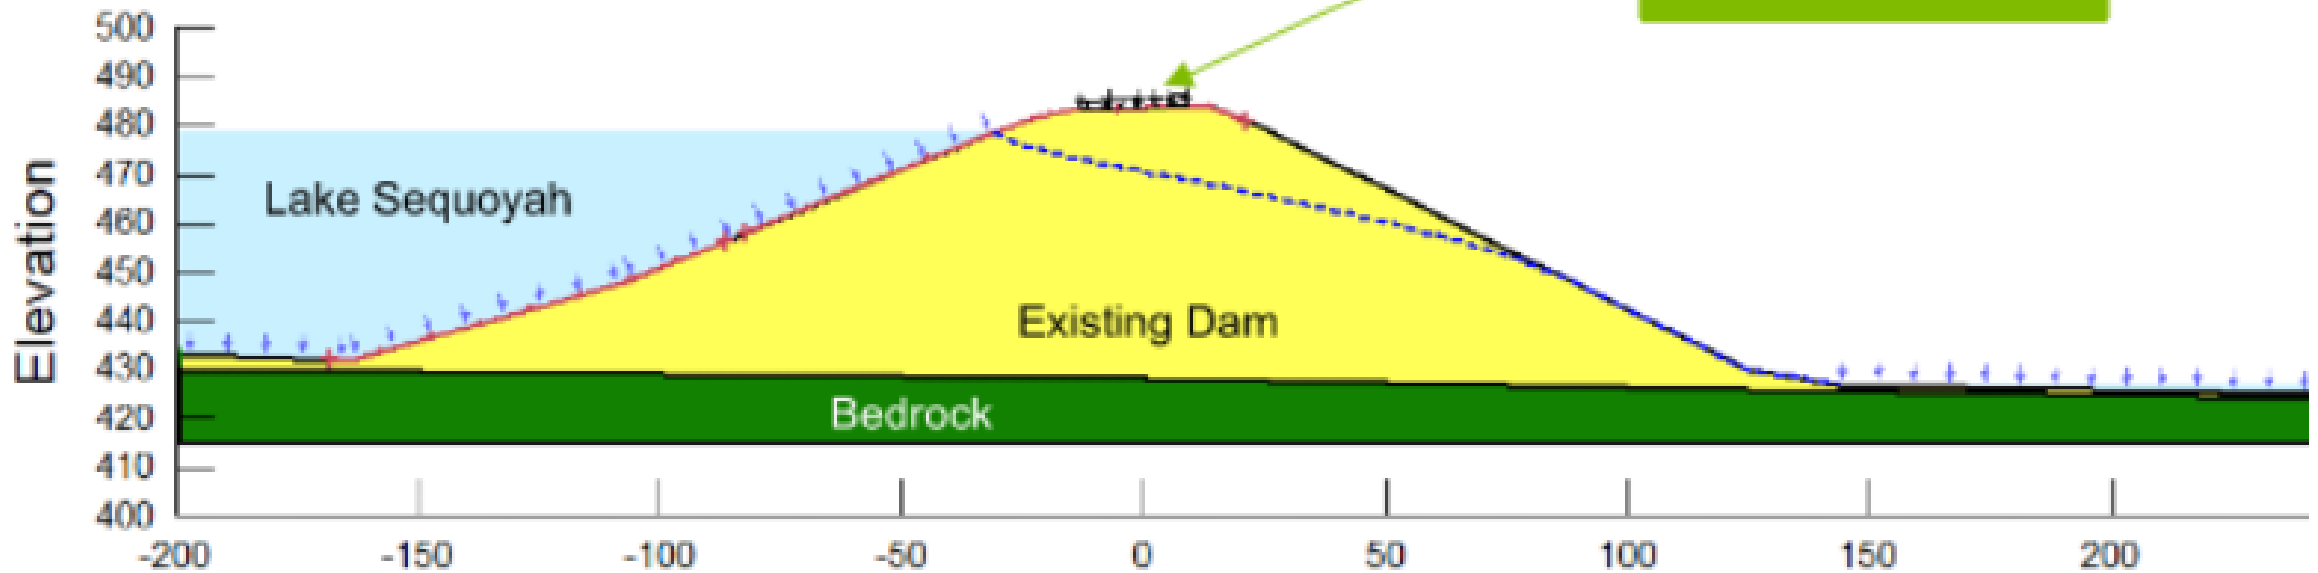
Color	Name	Unit Weight (pcf)	Effective Cohesion (psf)	Effective Friction Angle (°)
■	Bedrock	135	0	45
■	Dam Embankment	120	100	20

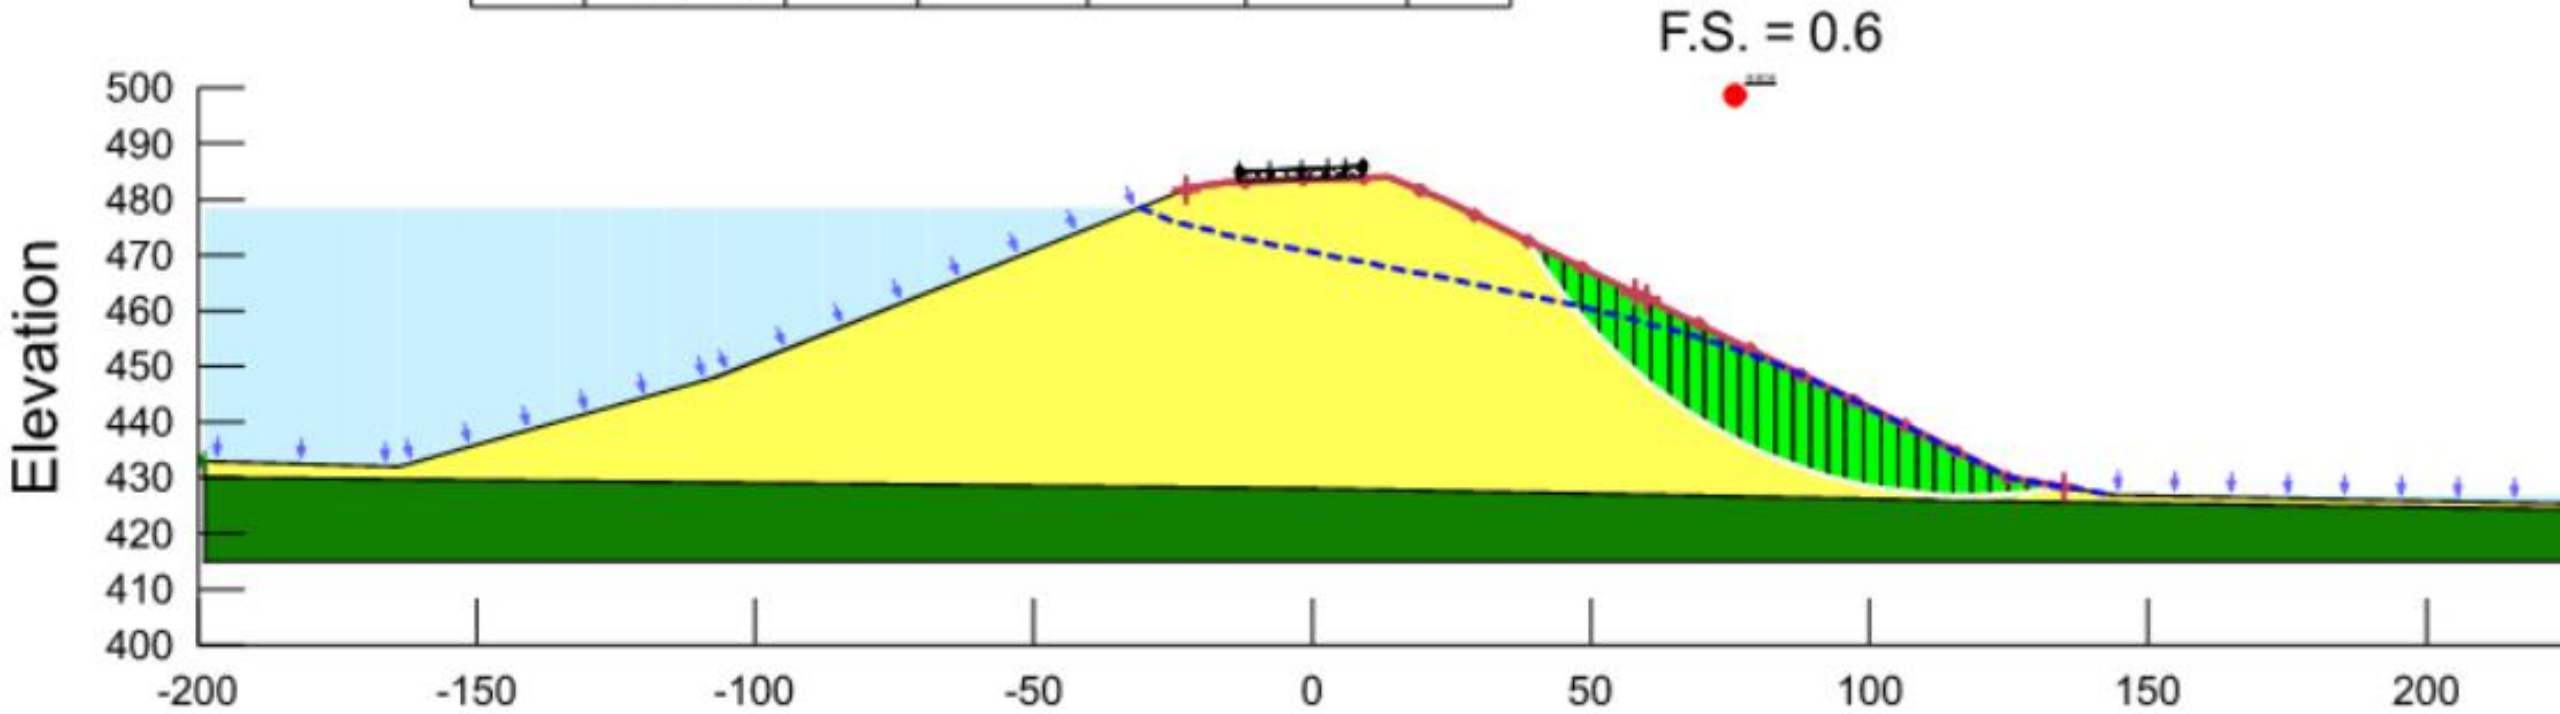
Color	Name	Unit Weight (pcf)	Effective Cohesion (psf)	Effective Friction Angle (°)	Cohesion R (psf)	Phi R (°)
■	Bedrock	135	0	45	0	0
■	Dam Embankment	120	100	28	500	16

- Conditions modeled to evaluate seismic loading, static conditions, steady state seepage, and multiple rapid drawdown scenarios from flood events and intentional releases.

Condition	Calculated Factor of Safety	Recommended Minimum Factors of Safety		
		USACE	USDA	NRCS
Steady-State Seepage, Normal Reservoir – downstream face	0.9*	1.5	1.5	1.5
Steady-State Seepage, Maximum Reservoir – downstream face	0.8*	1.4	1.2	1.4
Rapid Drawdown, Normal Reservoir – upstream face	1.7	1.3	1.3	1.2
Rapid Drawdown, Maximum Reservoir – upstream face	1.3	1.1	1.2	1.2
Seismic, Normal Reservoir – downstream face	0.6*	1.0	1.0	1.0
*The calculated factor of safety does not meet the recommended minimum factors of safety

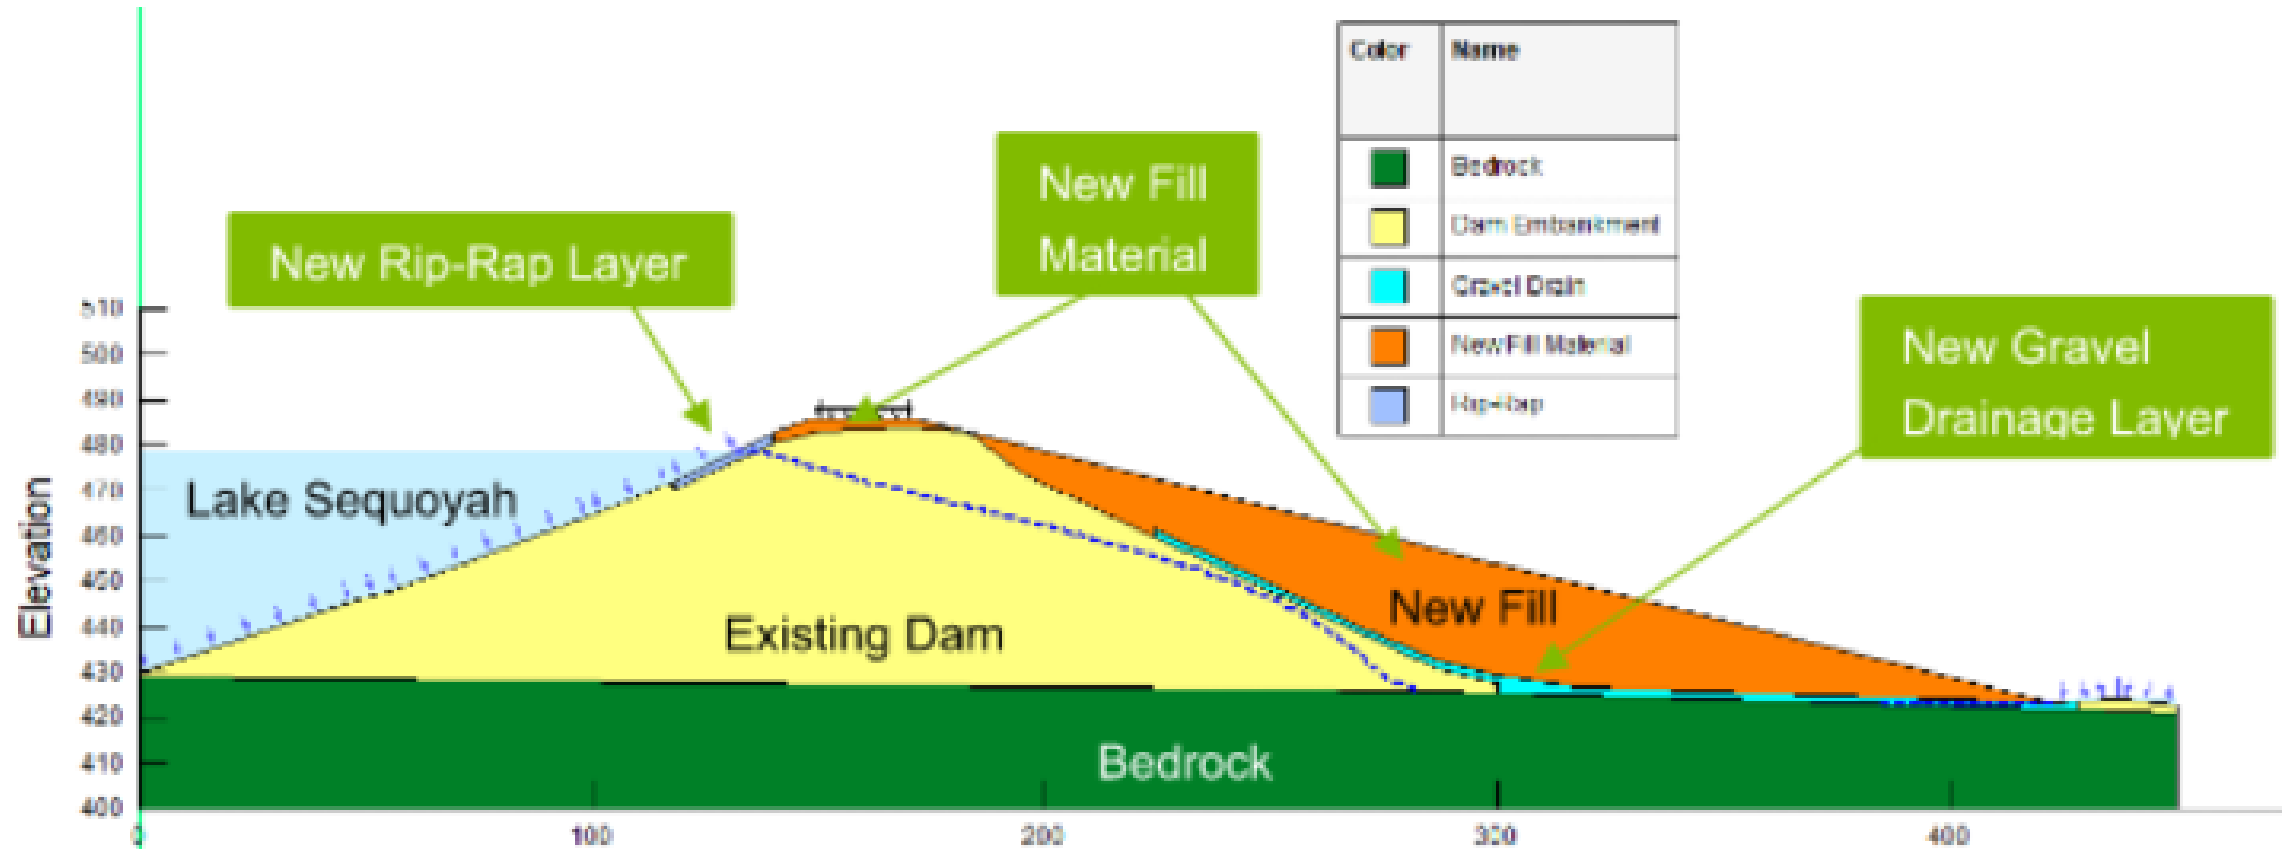
Geotechnical Evaluation of Proposed Conditions

- Small increase in height and roadway improvements
- Down stream 4:1 slope with underdrain system
- Up slope armoring for shoreline protection

Condition	Calculated Factor of Safety	Recommended Minimum Factors of Safety		
		USACE	USDA	NRCS
Steady-State Seepage, Normal Reservoir – downstream face	2.3	1.5	1.5	1.5
Steady-State Seepage, Maximum Reservoir – downstream face	2.2	1.4	1.2	1.4
Rapid Drawdown, Normal Reservoir – upstream face	1.5	1.3	1.3	1.2
Rapid Drawdown, Maximum Reservoir – upstream face	1.2	1.1	1.2	1.2
Seismic, Normal Reservoir – downstream face	1.2	1.0	1.0	1.0

Note: Some Factor of Safety values higher than required by rule. The final design could value engineer the improvements to reduce costs by iterating designs to minimize overbuild.

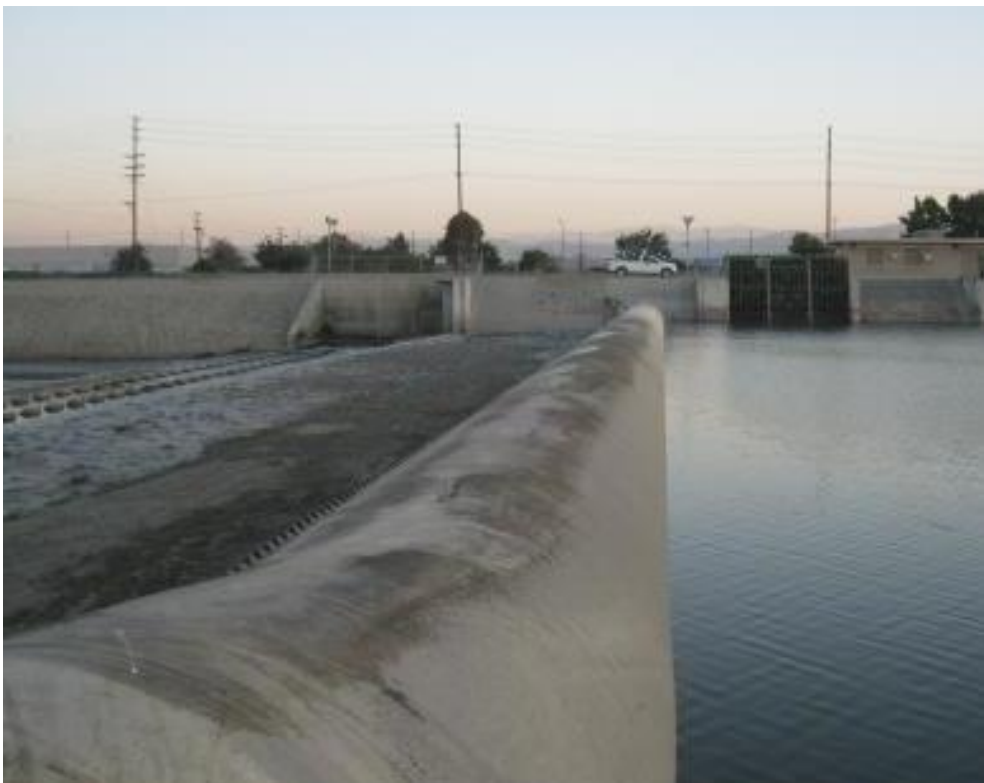
PROPOSED DAM SECTION

Existing downstream slope ± 4:1 (H:V) with stone slope armoring for erosion control protection

Earth and rock fill from spillway excavation on west side of site

Normal Pool ± 478.4 – Set by pneumatically controlled gate
