CVSID LAKE SEQUOYAH DAM ENGINEERING EVALUATION & CONCEPTUAL DESIGN

Public Meeting - November 17, 2025

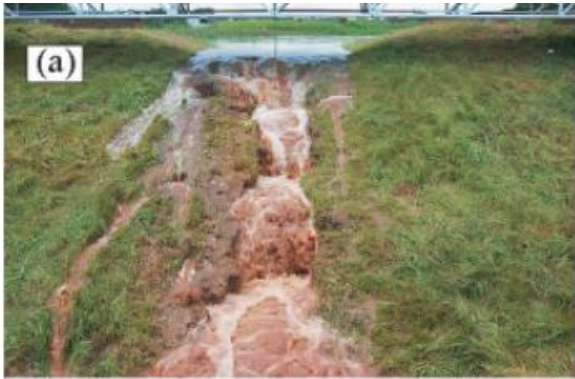
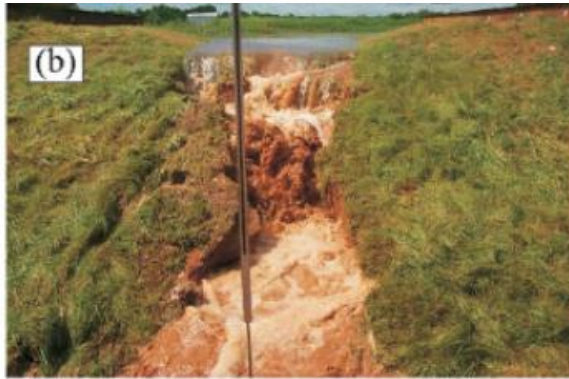
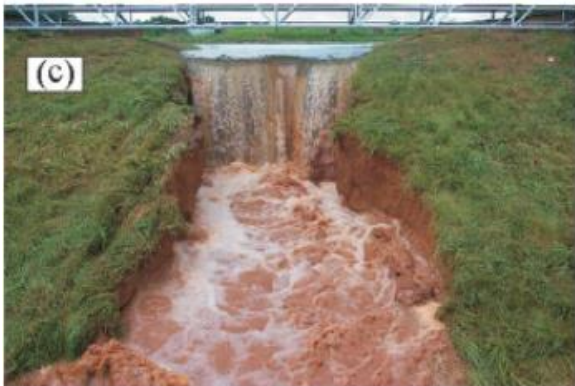
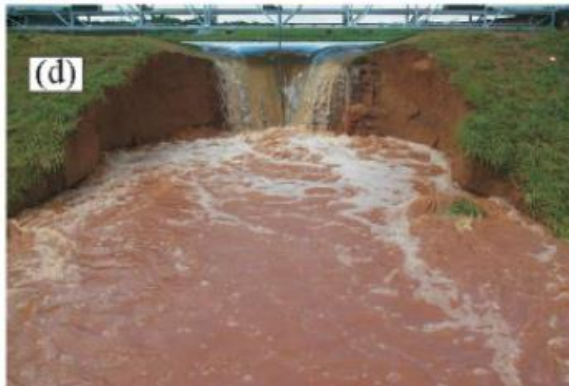
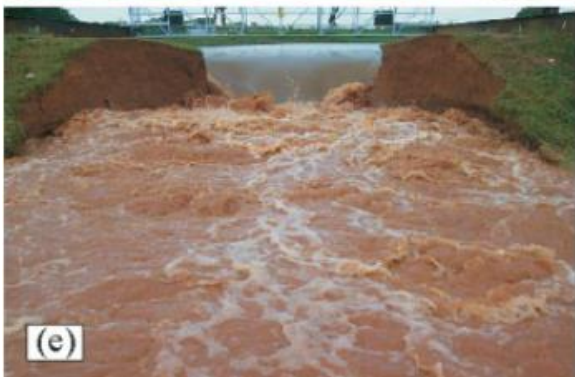
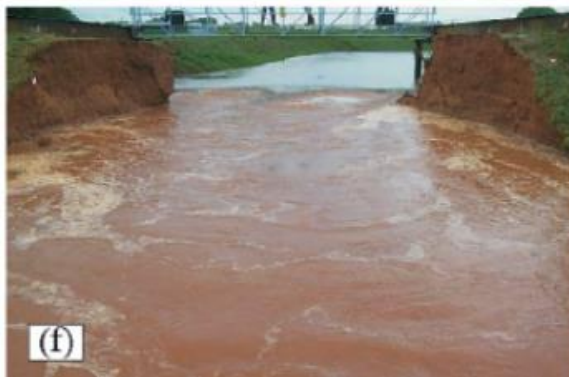
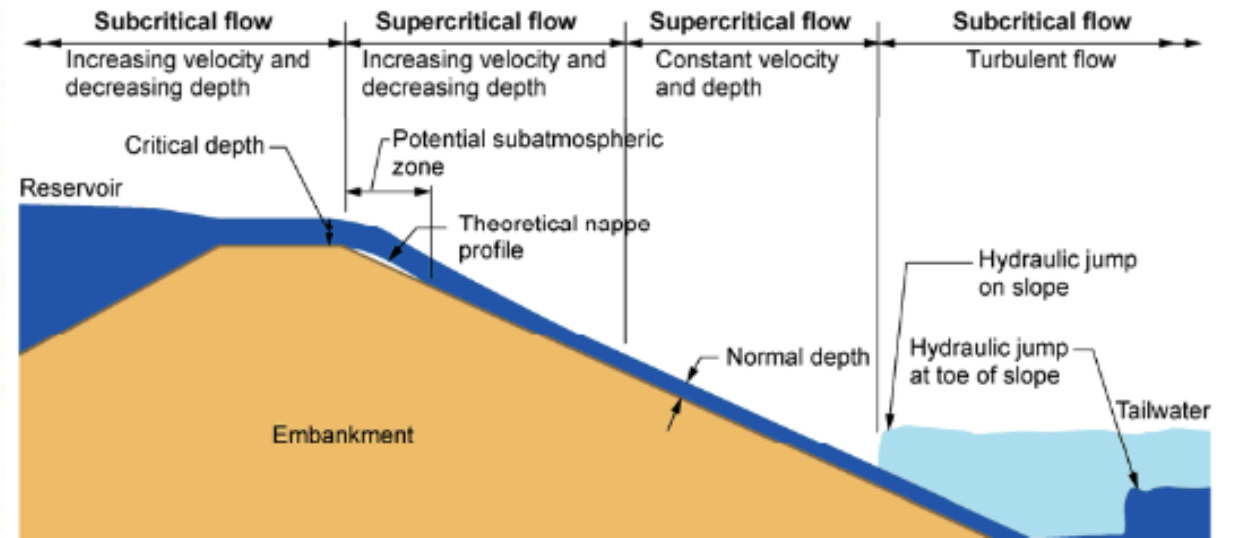
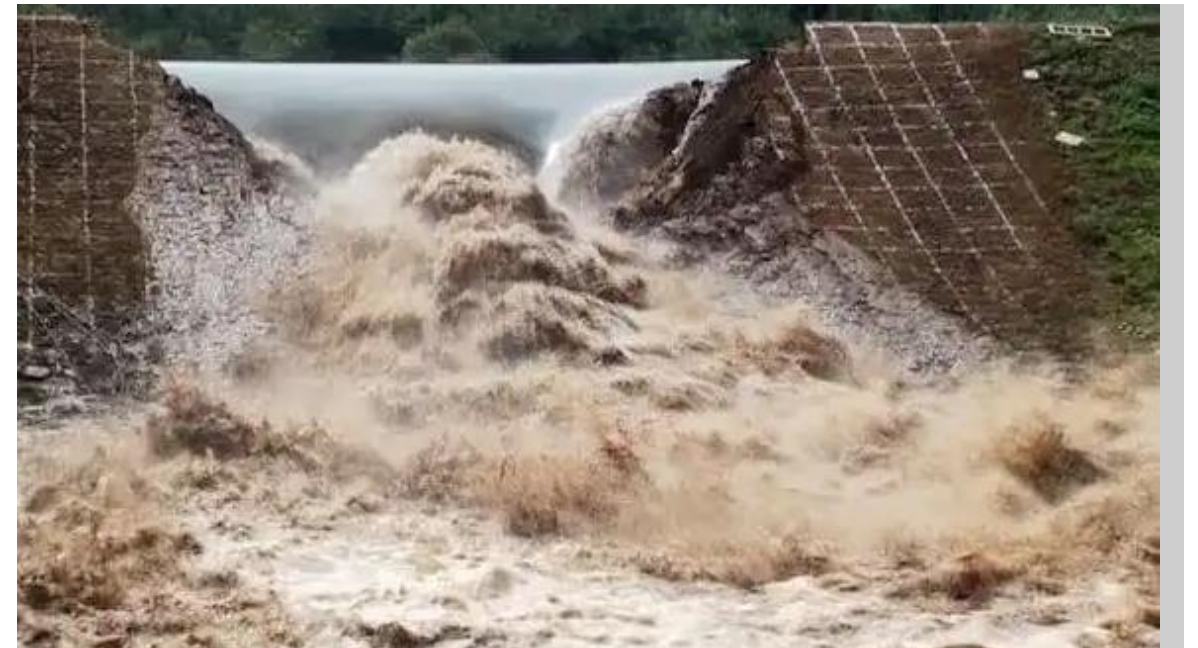
- Approximately 21,300 CFS total
 - ± 4,000 CFS passes through existing spillway.
 - ± 17,300 CFS overtops the dam and abutments with a depth of up to 3.8 feet maximum over dam face.
 - Flow over abutments is manageable but flow over earthen dam can be catastrophic.

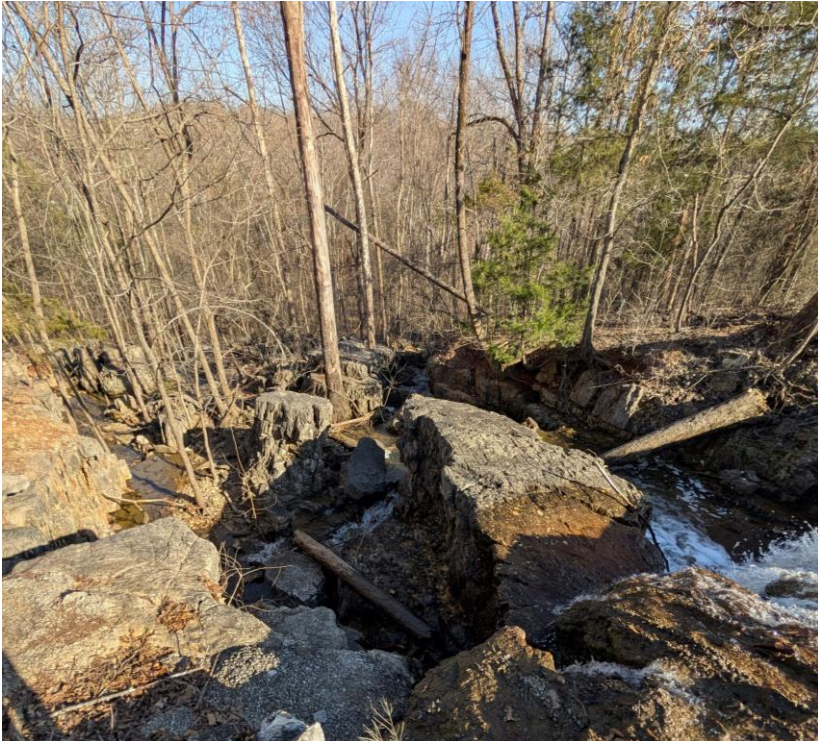
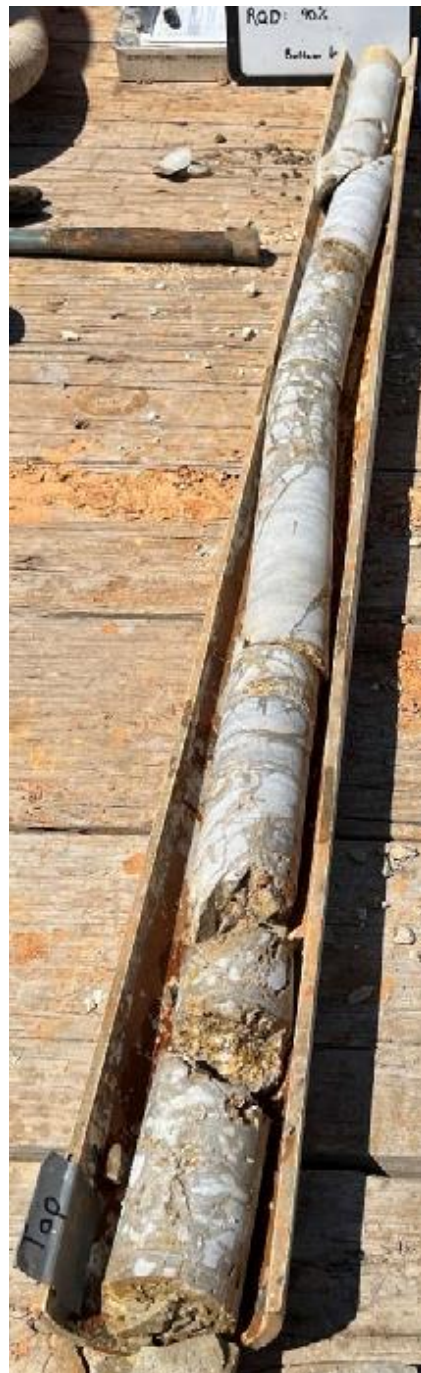
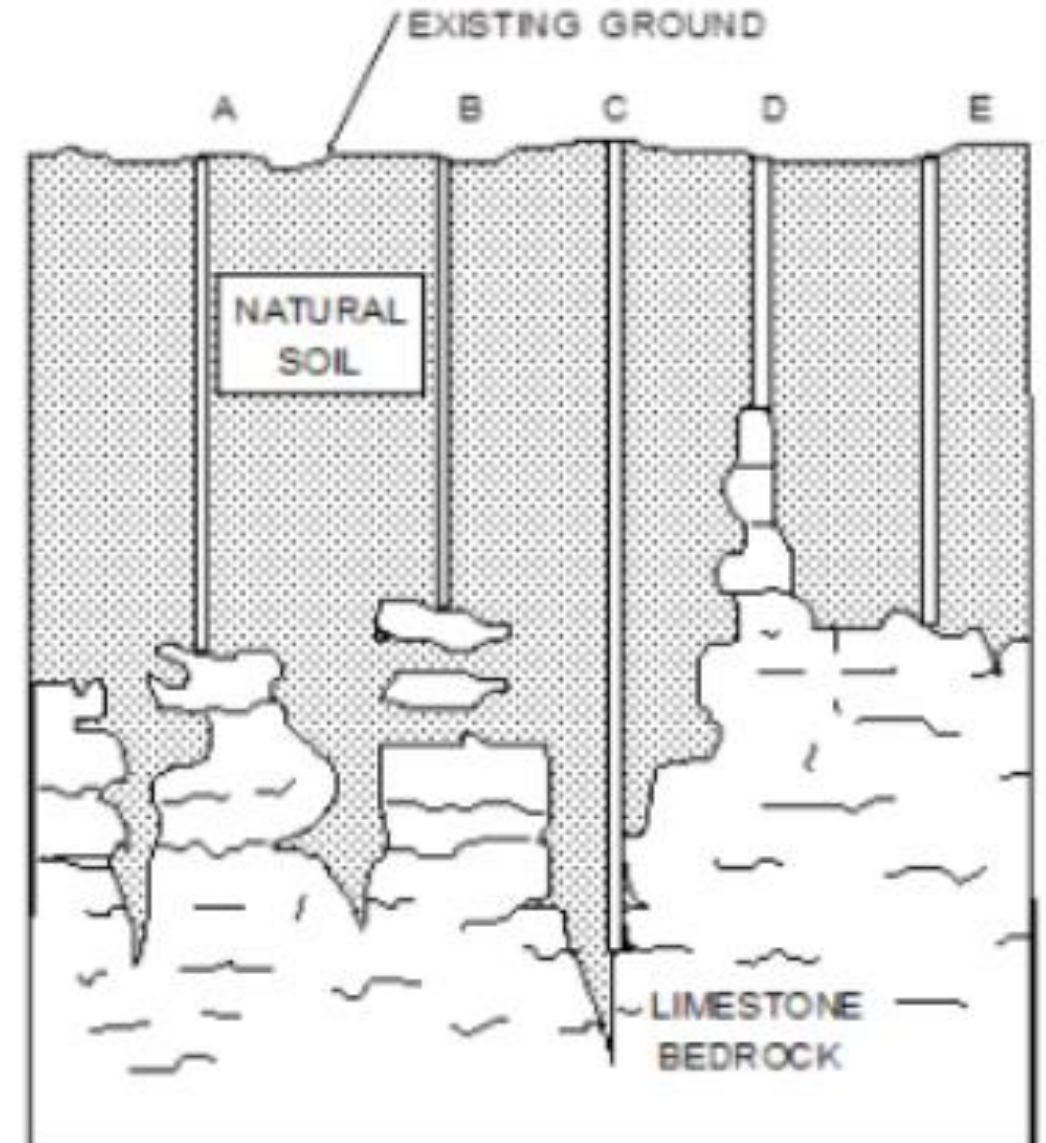
Karst Geology

Dam has a long history of geotechnical distress dating back to at least 1979 including sloughs and seepage which are still recurring today.

- Significant factor in seepage is likely karst topography.
- No apparent keyway in dam which could exaggerate seepage below dam.
